# Current and Innovative Solutions to Roadside Revegetation Using Native Plants

## A DOMESTIC SCAN REPORT

1. Report No. FHWA-WFL/TD-11-001	2. Government Accession No.	3. Recipient's Catalog No.	
4. Title and Subtitle  <b>Current and Innovative Solutions to Roadside Revegetation Using Native Plants A domestic scan report</b>		5. Report Date January 2011

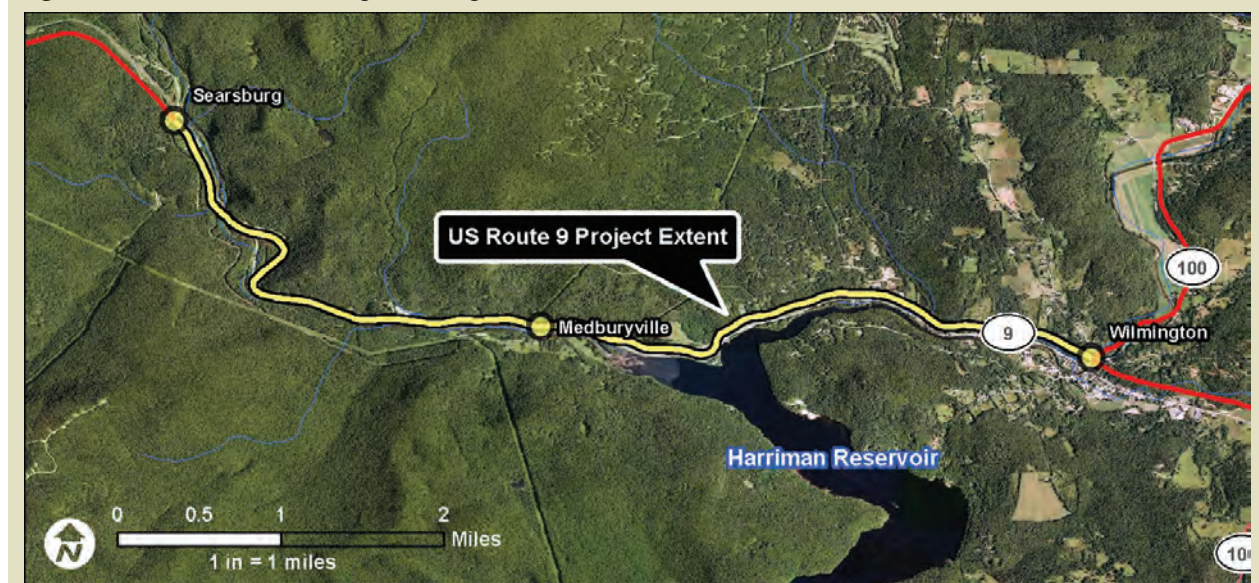
**Figure 2. US Route 9 from Searsburg to Wilmington**

The first roadside revegetation project observed by the expert panel was located along 3.67 miles of US Route 9 from Searsburg to Wilmington, Vermont (Figure 2). This site was a two-year highway reconstruction project that impacted many acres of roadside landscape and wildlife habitat corridors. The main purpose of the road reconstruction project was to widen the highway, upgrade conditions, and improve safety. As a designated National Highway System road, US Route 9 is held to a high standard of design to accommodate interstate transportation; US Route 9 was accepted for designation as a Vermont Scenic Highway.

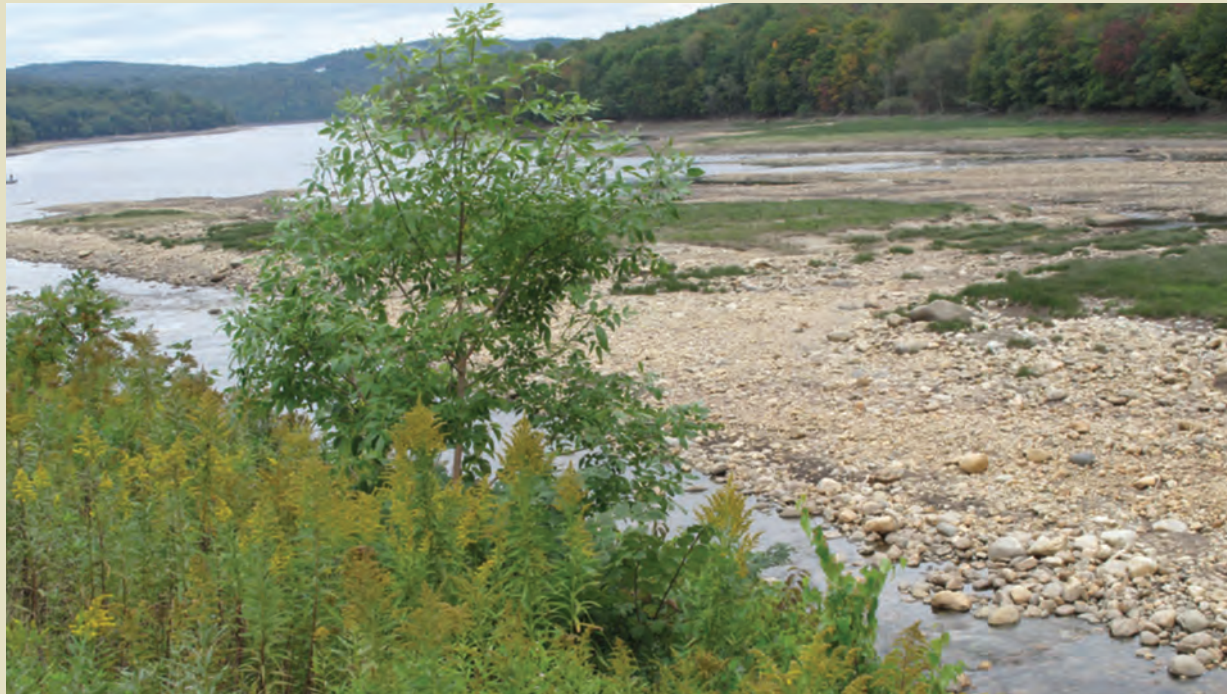
**Figure 3.** Planting pocket showing tree planting, with Harriman Reservoir in background

Planting pockets demonstrated that trees and shrubs can be established on a buried riprap slope if they are given additional room to expand their root systems. Since this project is less than five years old, the long term success of these plants remains to be seen; however, at the time of observation, there is no indication that they will fail. The decision to use this particular method will roadway engineer review to confirm that excavating from embankment riprap will not compromise the integrity of the erosion protection.

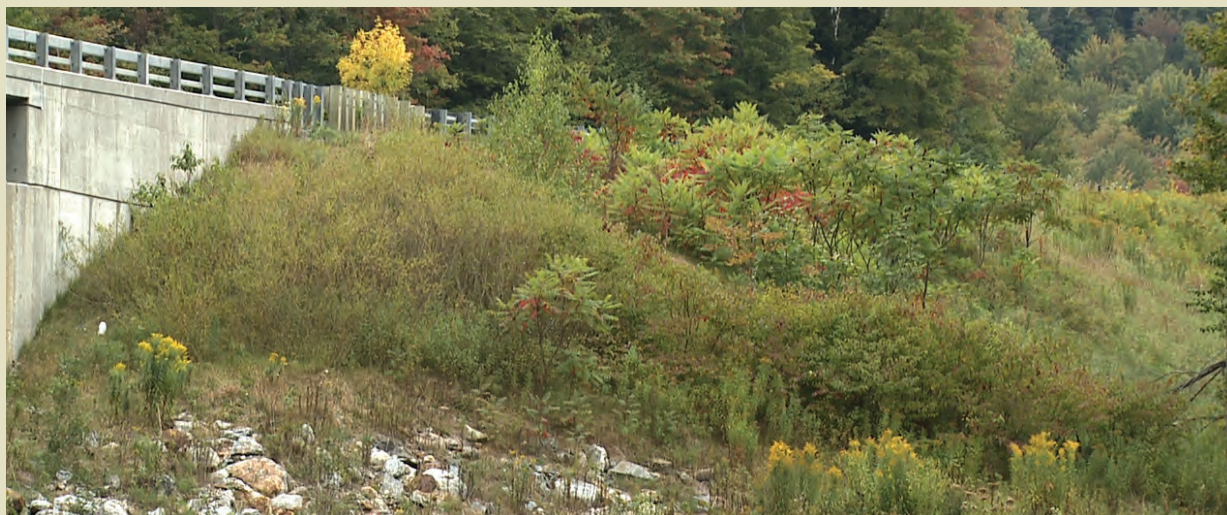
**Embankment Plantings** – Not all slopes required riprap protection as described above. Much of the roadside area did require planting on steep slopes; however, much of this landscape required only additional topsoil over the sub-soil (Figure 4). This technique facilitated planting of trees and shrubs in larger groups rather than the limitations imposed by planting pockets.

Although embankment plantings are not an innovative technique, these areas established quite successfully and provide large masses of native vegetation that contribute to the overall project objectives. The vegetation in these areas also includes the same native grasses, forbs, shrubs, and trees that were installed in the planting pockets, but the vegetation was installed in areas exceeding 100 feet in length and twenty feet in width.

**Figure 4.** Embankment planting on Route 9 near Wilmington, VT

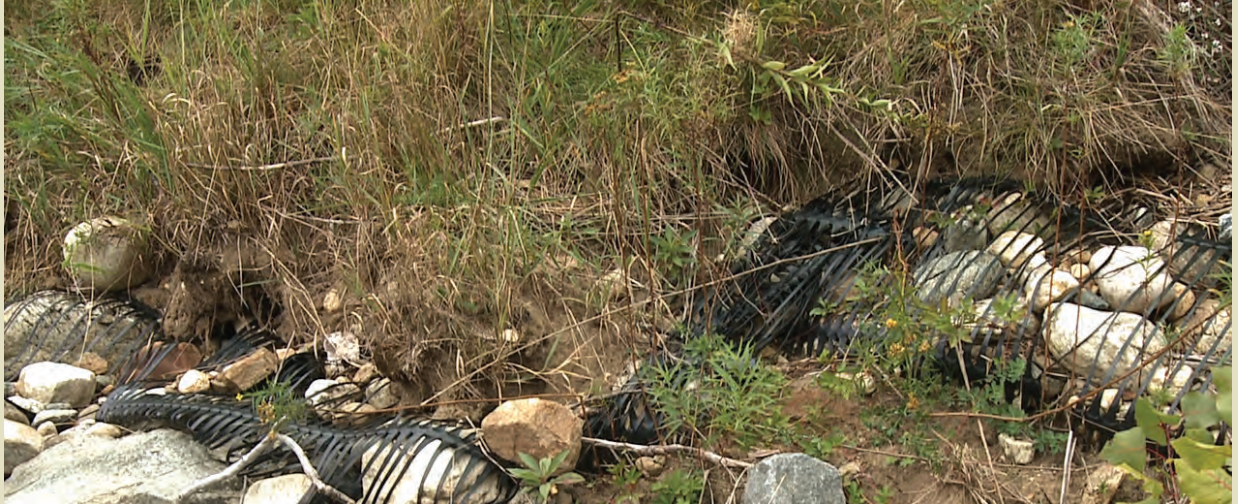
**Geogrid Sub-Base Stabilization Plantings** – A third planting technique was required for steep slopes created during road construction, when the sub-base of the road was built up in lifts of approximately 18". Instead of using riprap to stabilize the slopes, the engineers developed a method where the soil lifts were wrapped and contained in a geogrid material (Figure 5). However, the geogrid not only created a stabilizing structure for the embankment soil, but also created a barrier for root growth. Therefore, the landscape architect developed a specialized planting plan for these areas that only included grasses, forbs, and shrubs. Trees were not used because of the potential damage to both the geogrid material and to the tree roots themselves.

**Figure 5.** Geogrid sub-base stabilization planting near Wilmington, VT

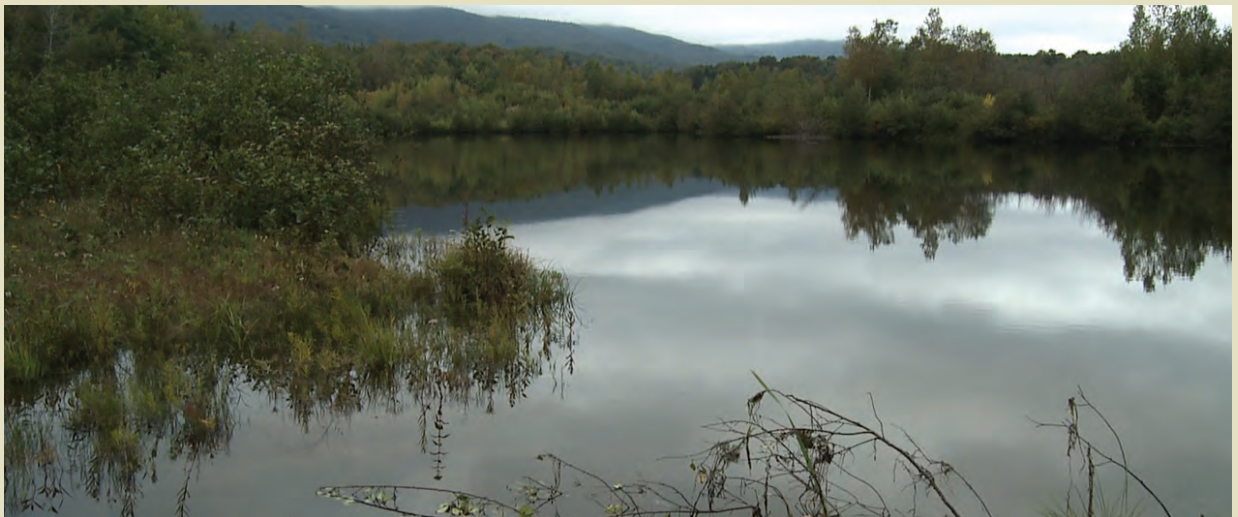
**Wetland Mitigation** – Another component to this project observed by the expert panel included a wetland mitigation site (Figure 6). This site was constructed under requirements set forth by the US Army Corps of Engineers for impacts to existing wetlands that occurred during construction of the road. Due to the lack of adequate on-site mitigation, all of the wetland mitigation was conducted at an off-site location that was approximately 15-miles from the town of Wilmington. The site was approximately 10-acres and located in abandoned gravel mine.

**Figure 6.** Wetland mitigation site near Wilmington, VT

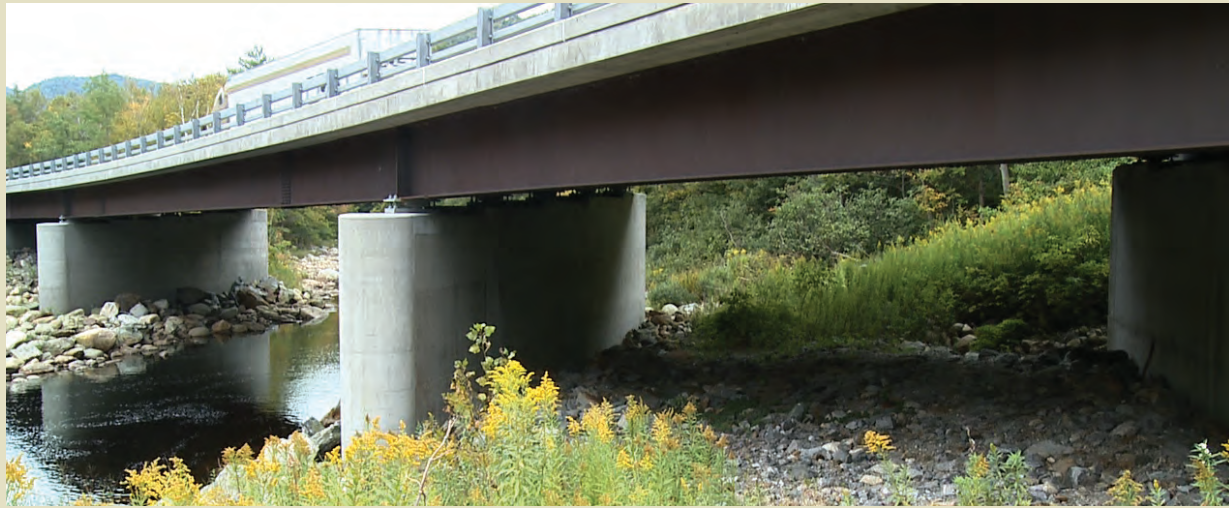
**Wildlife Underpass Crossings** – There are many incidents involving wildlife and traffic encounters in this area, so designers worked closely with staff from the Vermont Department of Fish and Wildlife to provide for animal passage under the bridges. These pathways were called “Critter Crossings” and were specially designed to allow animals, both large and small, the opportunity to pass under the bridges on stable footing (Figure 7). While this technique didn’t have a significant impact on the revegetation process, it is worth noting as a technique to improve safety for both humans and wildlife along State and Federal highways.

**Figure 7.** Critter crossing underpass near Wilmington, VT

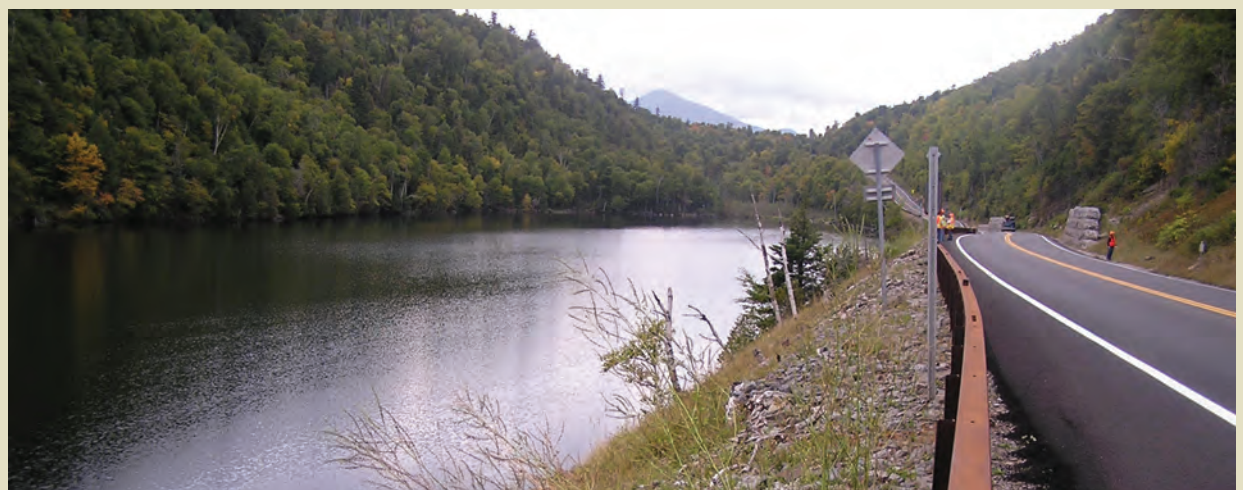
The landscape that lies between the roadway and the lakeshore is very narrow and steep with poor topsoil (Figure 9). There is evidence of soil erosion caused by stormwater runoff that flowed off of the road and into the lake. Additionally, the sand and salt used to control the ice have washed off the road, smothering the bases of trees, shrubs, and grasses at this site. One species in particular was noticed to be experiencing a higher than normal (and unexplained) mortality rate - the white birch (*Betula papyrifera*).

**Figure 9.** Route 73 at Cascades Lakes Pass showing steep slopes with rocky soils

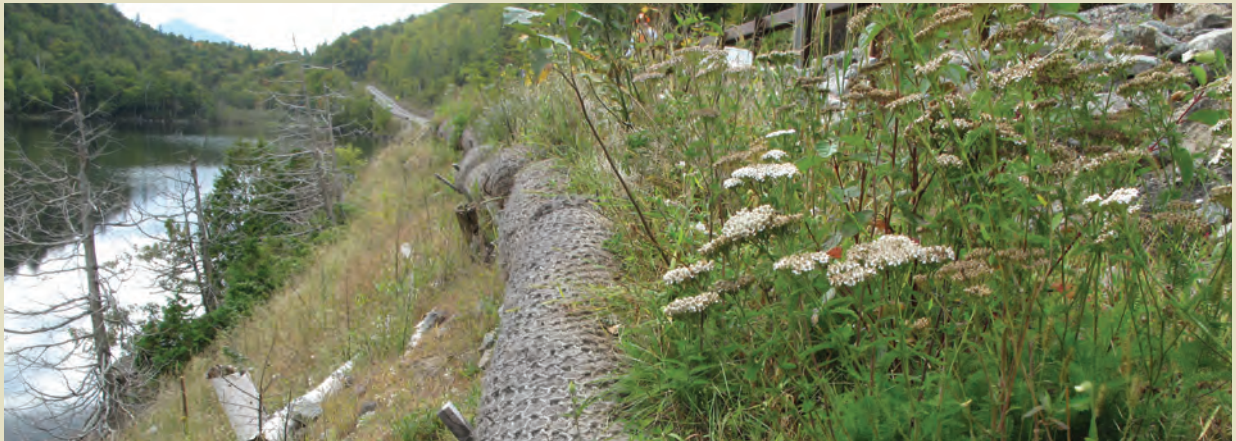
**Coir Log Planting Bench** – Several of the planting locations were on very steep grades with extremely poor topsoil. Revegetation would have been nearly impossible without the use of a method to create more favorable planting conditions on these extreme slopes. Additionally, the area was located in a narrow area that was wedged between the highway and the lakeshore. Working the site with heavy equipment and attempting to install plants on near vertical slopes would have been impractical; therefore, coir logs were installed by hand and then topsoil was placed behind them to create a planting bench (Figure 10). This method created a stable planting area with good water holding capacity on an otherwise harsh site.

**Figure 10.** Coir log planting along Route 73 with Cascade Lakes in the background

After two complete growing seasons the results are mostly successful. The coir logs have created hospitable conditions for plant materials on the upslope side and along with the imported topsoil have effectively held water. The planting benches also support good growth of the trees, shrubs, grasses, and forbs that were installed by the crew. Following is a list of species that were planted from container plantings:

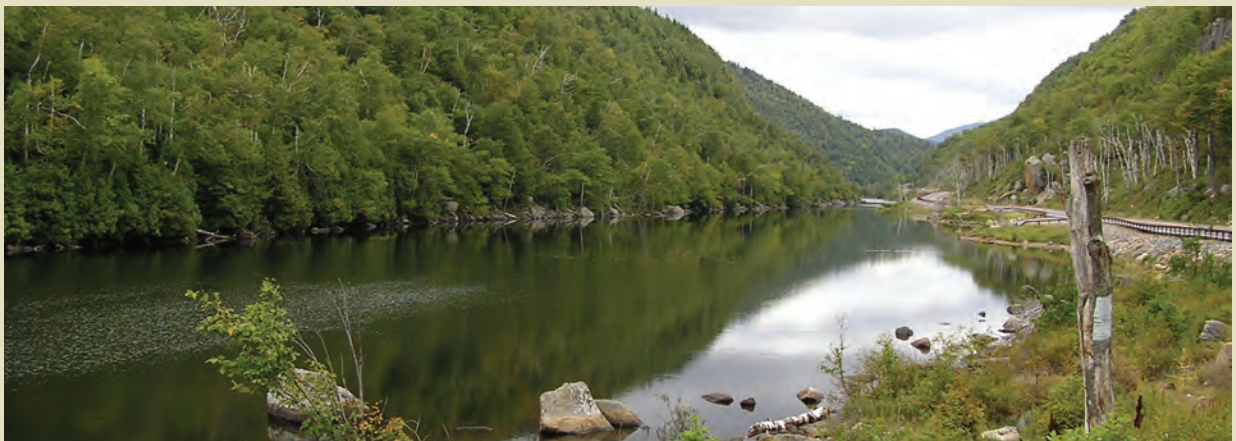
**Living Snow Fence** – The snow and ice that accumulates on the road in winter creates a very dangerous situation for drivers and presents a constant challenge for the maintenance crews. Wind blows through the valley and across the frozen lake, depositing drifting snow and ice across the roads. One of the study recommendations was to install a living snow fence created by planting native evergreen trees (Figure 11). Although the plants that were installed are only approximately 3' in height, it is anticipated that eventually the plants will reach sufficient height to provide a barrier and prevent excess snow and ice from accumulating on the roads.

White spruce (*Picea glauca*) trees were planted due to their ability to withstand wind, heat, cold, drought, and crowding. In addition, these species are salt tolerant and are native to the Adirondacks.

**Figure 11.** Living snow fence area at Cascade Lakes Pass; small spruce trees planted for the eventual snow fence

One documented problem is that three of the white spruce did not survive or appear to be extremely stressed. The NYSDOT replaced these species with additional tamarack (*Larix laricina*), which will function similarly to the white spruce. Subsequent to the site visit, NYSDOT determined that most of the white spruce did not survive—likely a result of the wet planting conditions near the lake—and they have been replaced with tamarack.

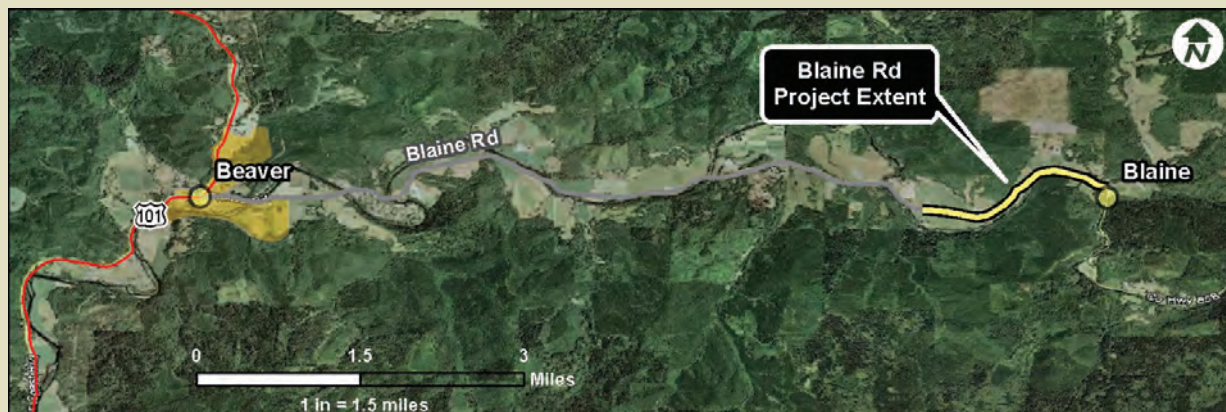
Figure 12. Blaine Road

This road improvement project for Blaine Road begins near the town of Blaine, OR and travels approximately four miles through lands owned by the US Forest Service, the Bureau of Land Management, and lands that are held by private land owners (Figure 12). These lands border the Nestucca River, which is designated as an Oregon State Scenic Waterway and plays a significant role in the revegetation efforts. The first 1.5 miles of the road project traverse a broad valley of private land and then enters a steep canyon of federal land.

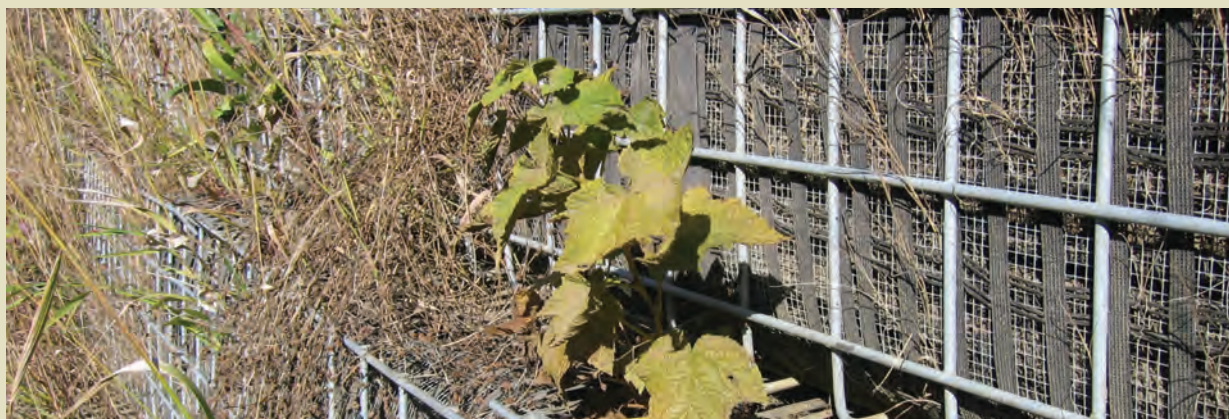
**Figure 13.** Mechanically Stabilized Earth Retaining Wall planting

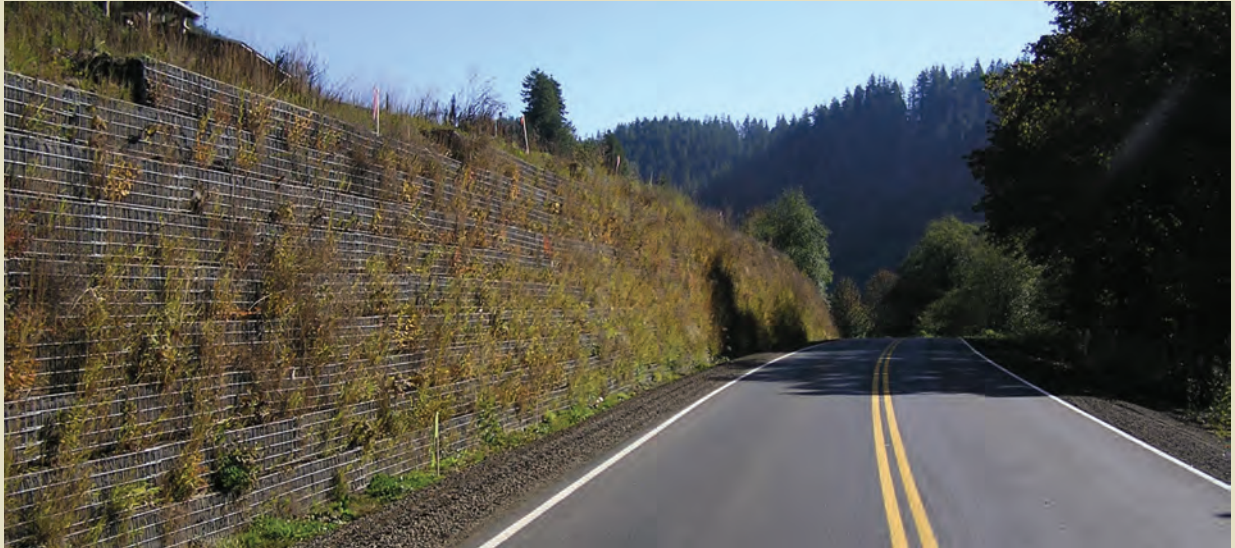
The MSE wall is a modular wall that uses welded wire material and geogrid fabrics in combination with both structural soils and topsoil to create a modular system (Figure 13). The topsoil is placed on the inside face of the walls to a depth of approximately 12 inches to ensure the face of the wall and the stepped ledges are capable of supporting plant materials. Container plants and grasses were installed by hand to create the vegetative screening along the wall structure.

**Figure 14.** Vegetated mechanically stabilized earth wall on Blaine Road

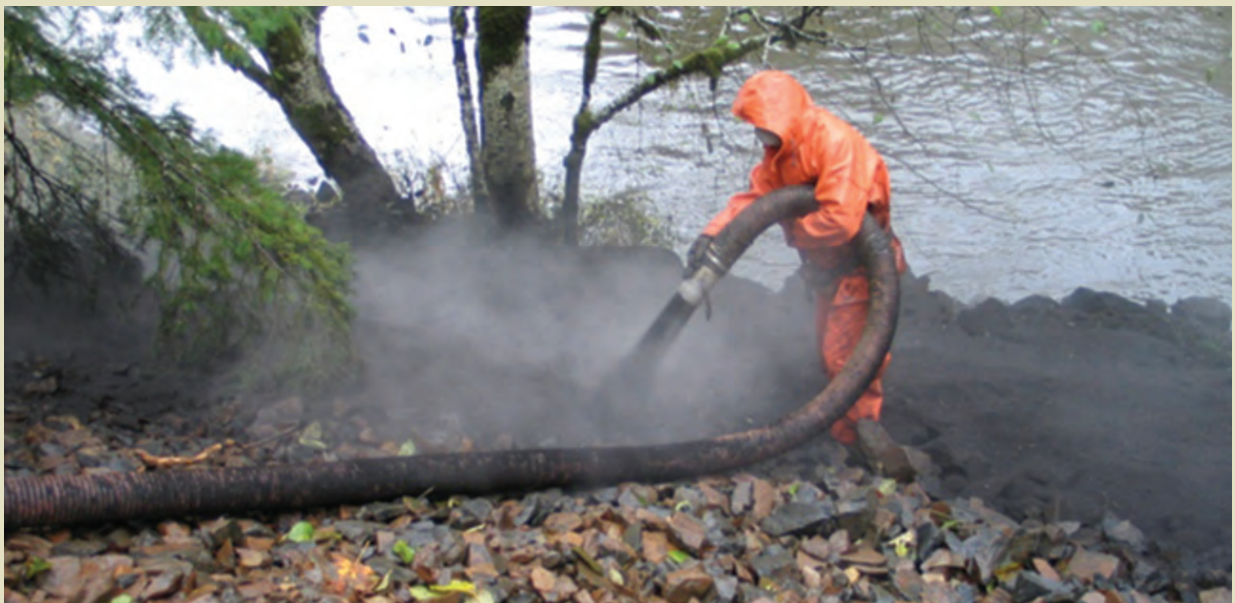
**Vegetated Riprap Areas** – Because of the strict revegetation standards set forth by the regulatory agencies pertaining to riprap areas around the culverts, an innovative approach had to be developed that would allow plants the opportunity to properly establish (Figure 14). Riprap was installed to prevent soil erosion in steep areas and along drainage culverts, but the shortage of adequate topsoil for cover over the riprap was a constraint. Further, some of the sites that were on very steep slopes would have present complications in the installation of topsoil, even if adequate topsoil were available.

The project team determined that a blown-in-place compost material could be applied that would provide plants with a favorable growing medium over the riprap. The consistency and relative ease of application made this a good choice to fill the voids and to build up a five- to ten-inch layer above the rock material. Not only was the ease of application a plus for the project, but the material itself is a very nutrient-rich compost that is made out of recycled organics containing beneficial bacteria, mycorrhizal fungi, and a binding agent to prevent wind and water erosion. The compost was blown in place through a low impact, pneumatic method and was mixed with the native grass seed mix in one application process.

**Figure 15.** Application of compost over rip rap

The compost with tackifier was stable through several very intense rainstorms and held the soil even without the use of a surface erosion fabric. Moisture in compost remained relatively high during August without supplemental irrigation.

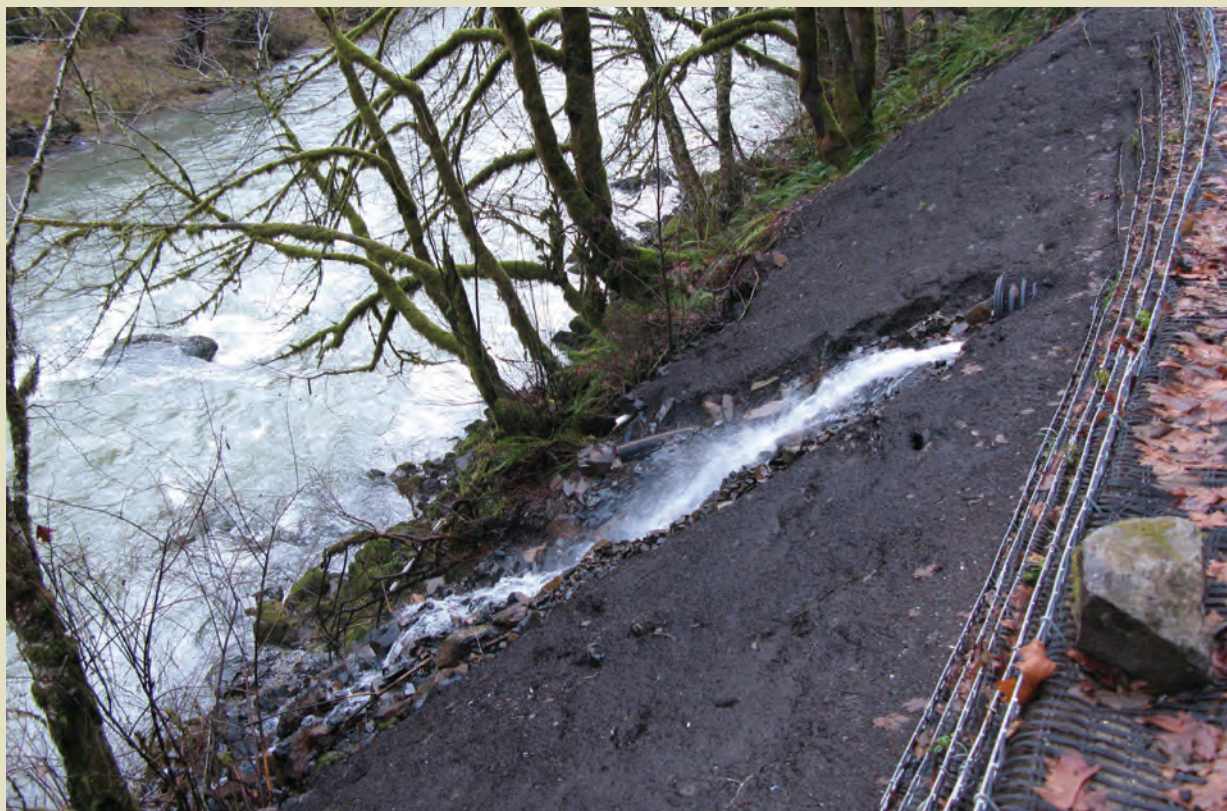
In January of 2009, approximately 2,800 tree and shrub materials were planted by hand to meet the desired future condition of twelve native shrub or tree species per 100 square feet (Figure 15). This plant material was able to survive even during the drier summer months because the compost held an ideal moisture level throughout the year (Figures 16 and 17).

**Figure 16.** Compost over riprap at culvert prior to plantings

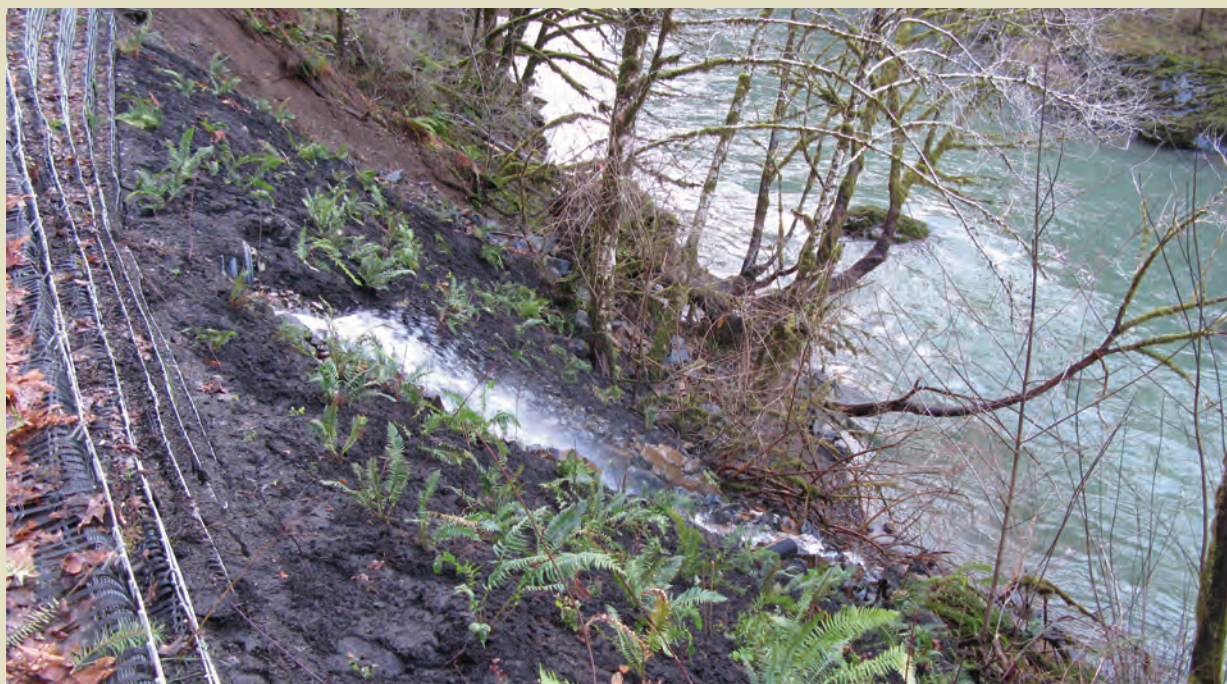
**Figure 17.** Compost over riprap at culvert after planting

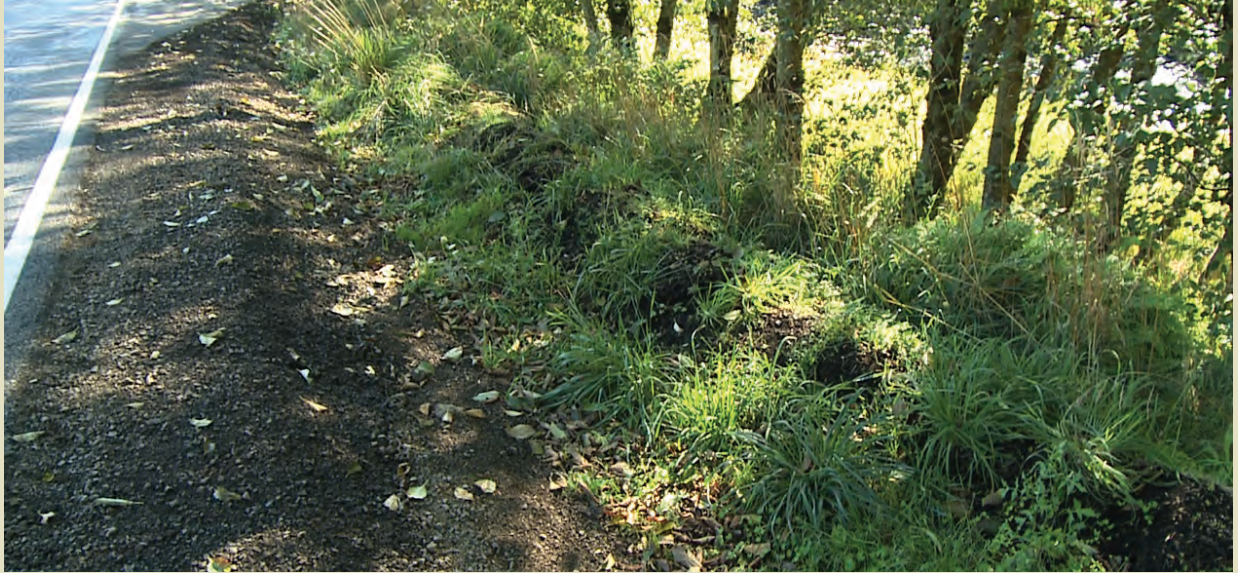
**Compost Berm.** As an alternative to using a silt fence, project managers decided to install a compost berm between the construction zone and the adjacent Nestucca River as a means to prevent sediment runoff. Due to the rocky soils, the use of a silt fence would have caused unnecessary damage to the landscape during installation (Figure 18). However, the compost berm was a reliable option without causing harm to the riparian zone. In addition, the berm itself was planted with a native seed mix that ultimately provided visual screening of the BMP when the grasses began to establish.

**Figure 18.** Compost berm

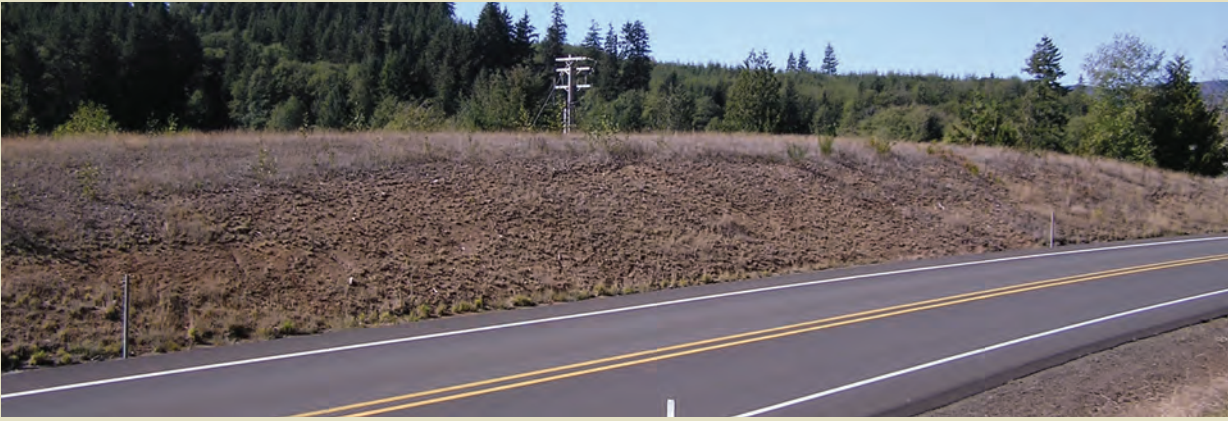
Figure 21. Example of hydroseeding without using blown in place mulch on Sandlake Road

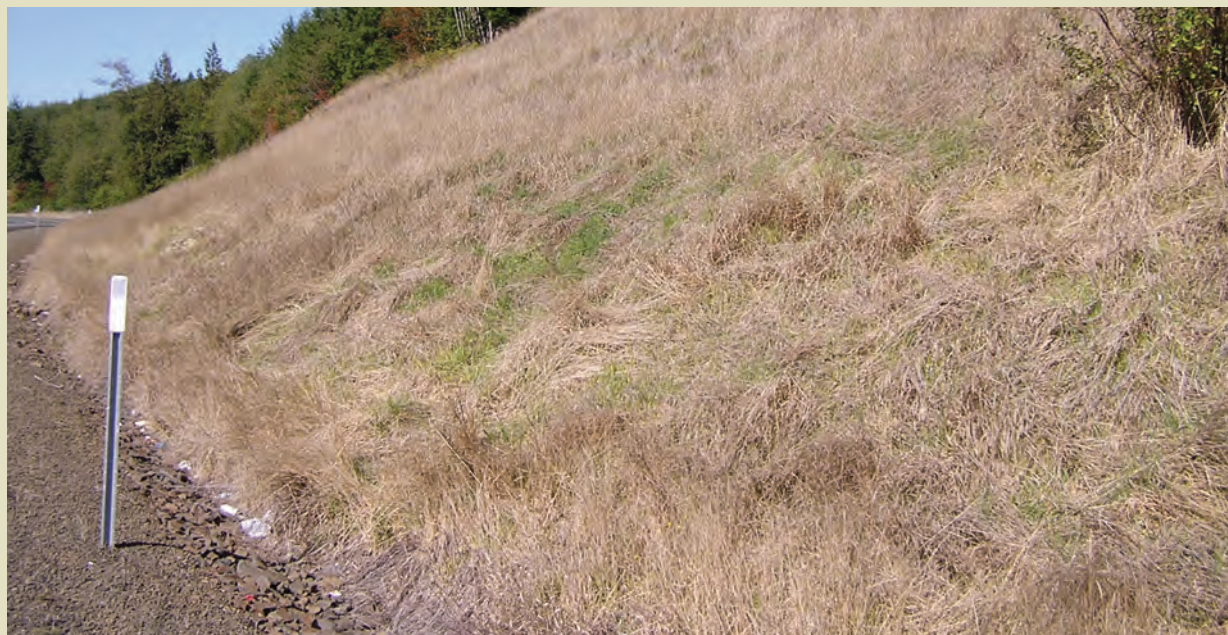
**Figure 22.** Example of seeding on steep slope and using blow-in-place compost on Sandlake Road

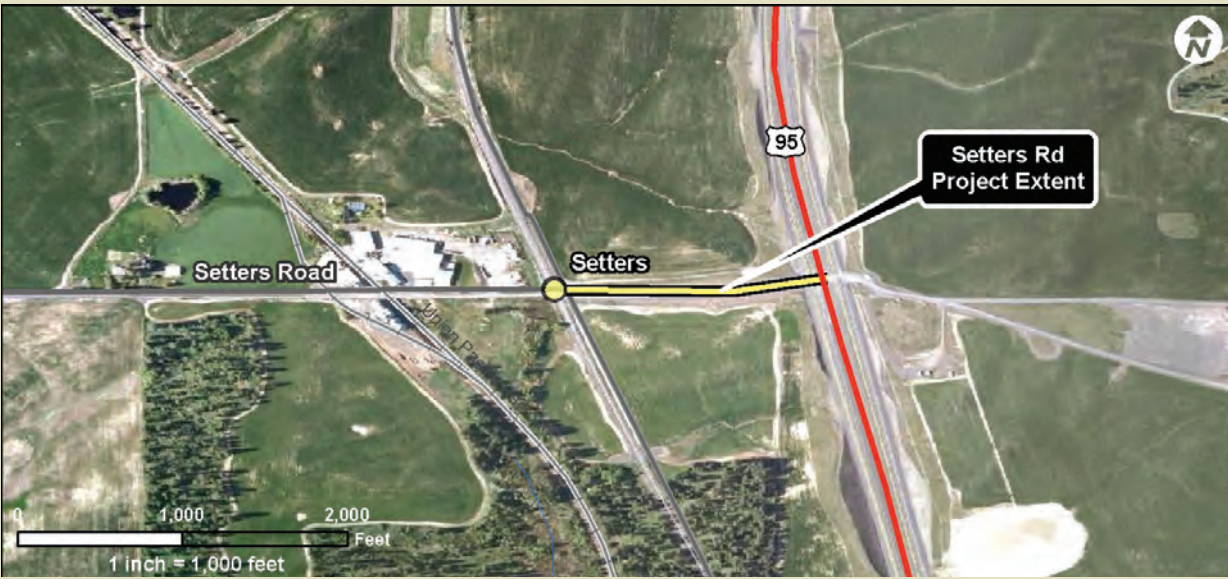
Figure 23. Setters Road construction

Roadside revegetation at the Setters Road site was located approximately 5 miles north of the town of Worley, Idaho (Figure 23). This effort was part of the on-going statewide reconstruction of US-95. Setters Road is approximately 1,000 linear feet of new roadway constructed to extend and connect the existing portion of Setters Road to US-95. The revegetation within the observed area covered both sides of the newly constructed roadway, which is oriented in an east/west direction, giving the new cut slopes a north and south aspect.

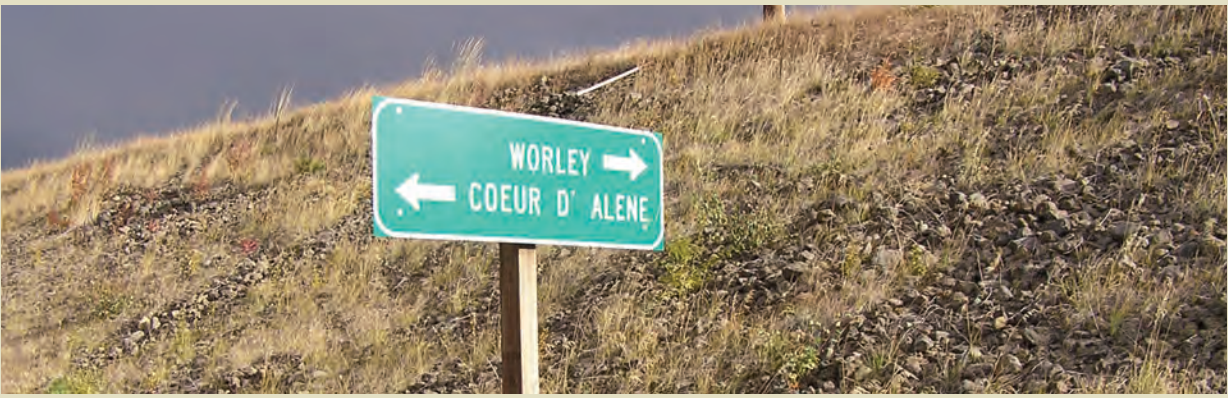
Figure 24. North facing slope with rock mulch and vegetation on Setters Road

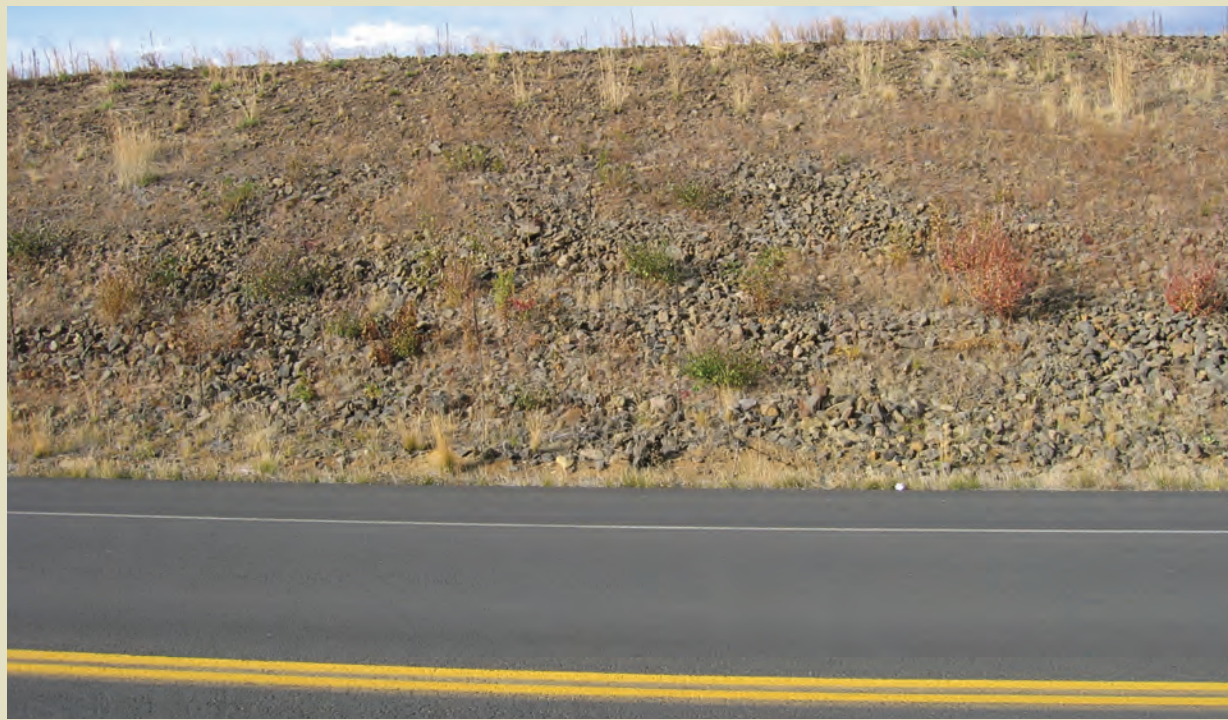
As dirt washed away and/or settled into the voids in the rock mulch, the shrub seeds also settled into pockets between the rocks. Eventually, the seeds with ideal conditions began to germinate.

**Figure 25.** Cut slope on Setter's Road three years after revegetation efforts

At the time of the site visit, the project was a little over three years old and there were many specimens of shrubs that were at least 4 feet in height and many more that were beginning to emerge (Figure 25). In addition, there were volunteer species of shrubs and perennial grasses that had begun to establish.

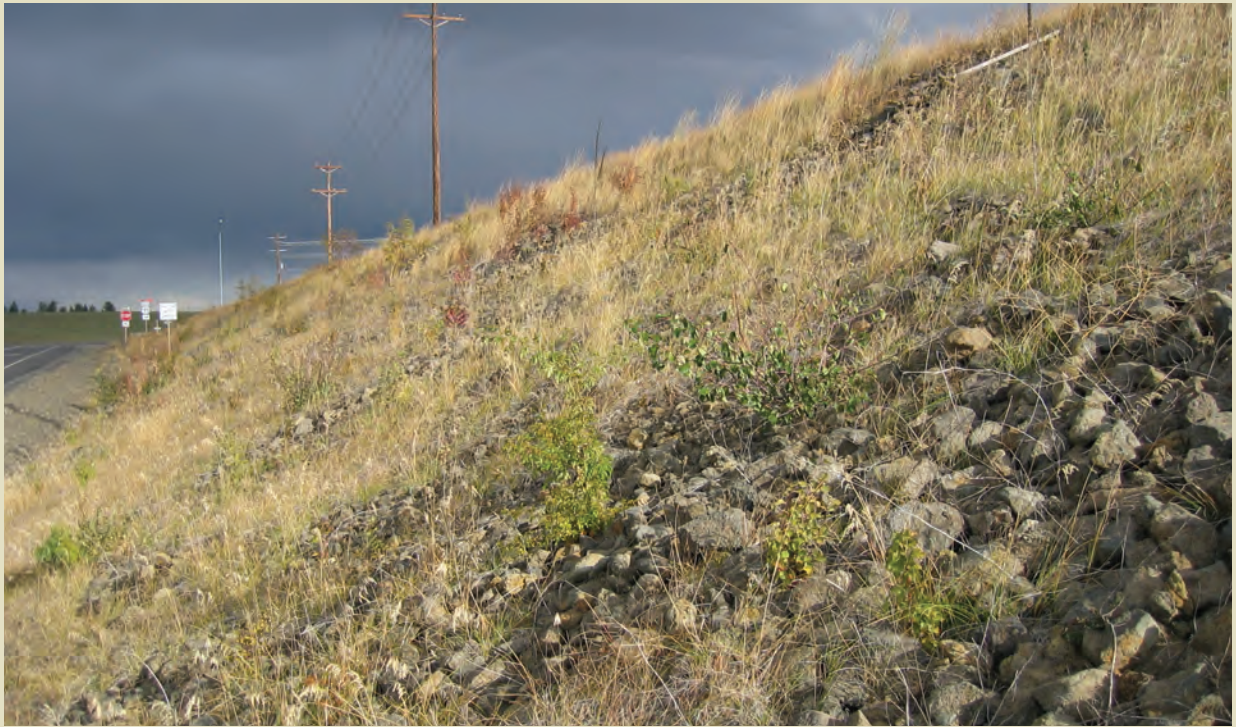
**Figure 26.** Setters Road rock mulch and revegetation

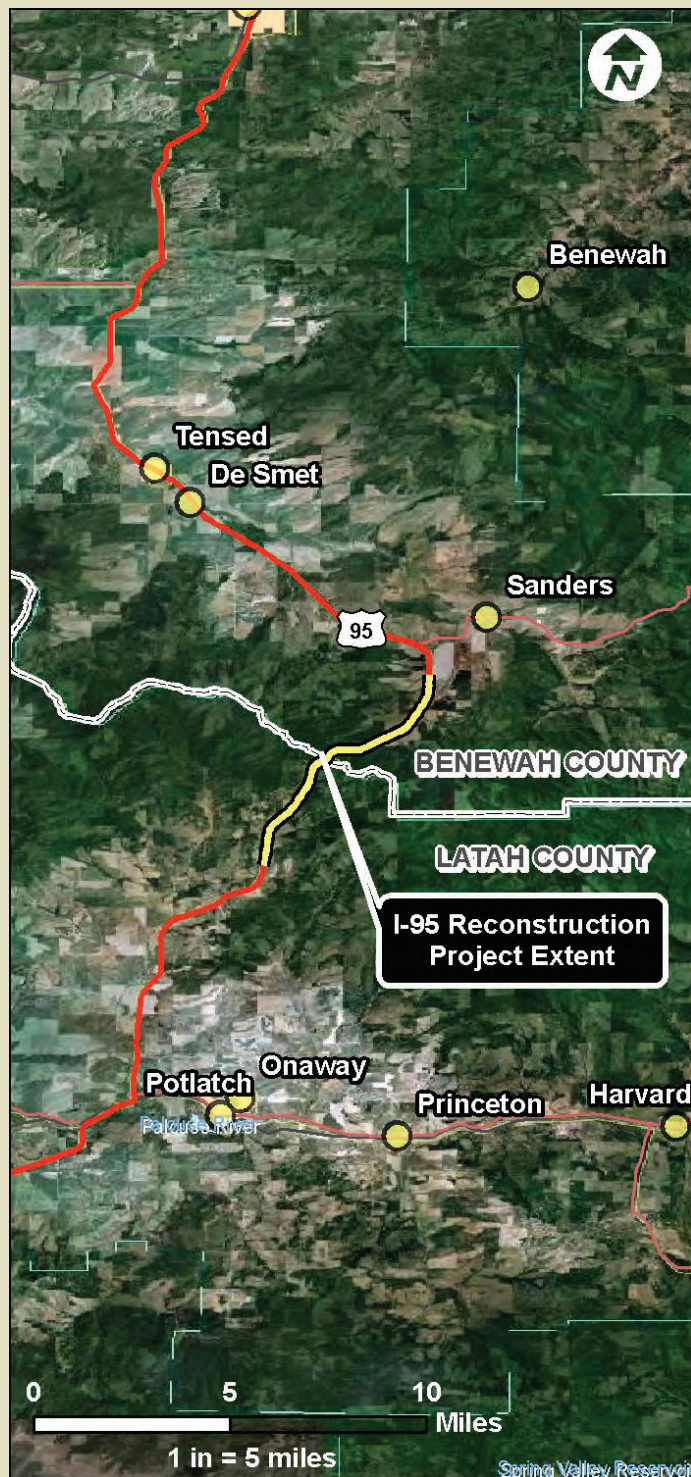
**Figure 27.** Smith Creek reconstruction and revegetation

The project consisted of alignment improvements to 6.6 miles of US 95 in Benewah and Latah Counties (Figure 27). The project area extends through the Palouse Prairie consisting of Palouse Prairie vegetation and organic soils, as well as mixed pine and Douglas fir. Most of the project is within rolling terrain, while mountainous terrain exists for approximately 1.8 miles of the project as the roadway passes over the Marsh Hill summit at the county line. Significant improvements were made to the horizontal and vertical alignments of the roadway to improve safety for travelers and maintenance crews. Some of the project

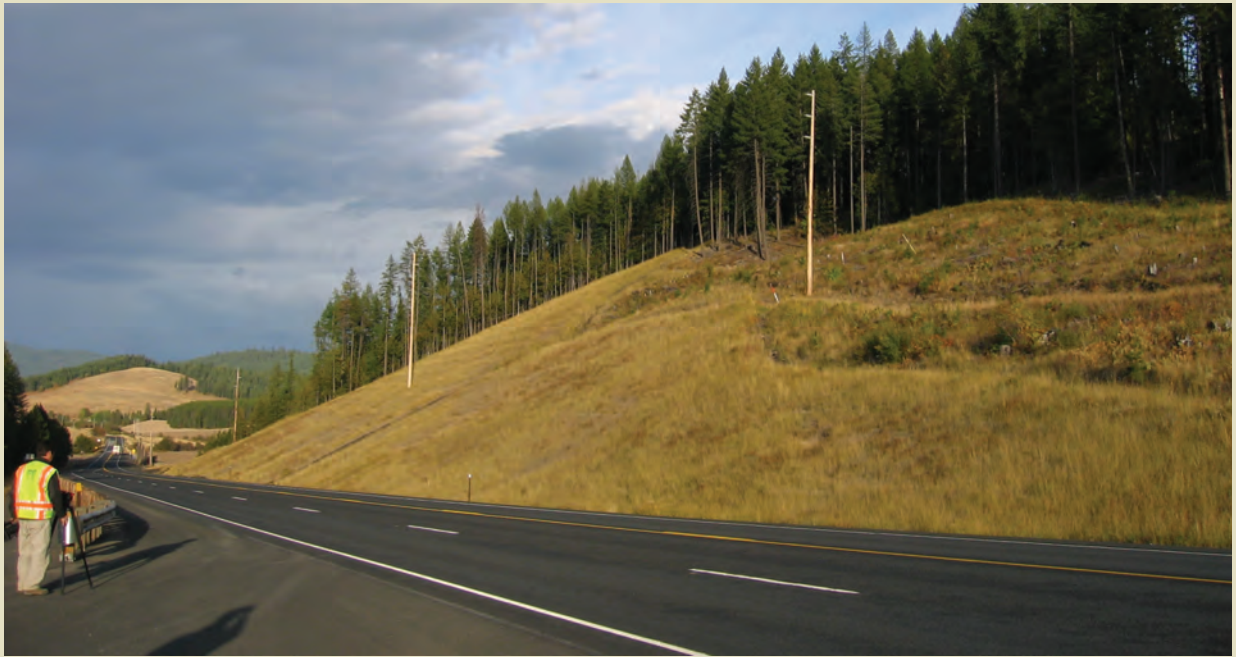
**Figure 28.** An example of a successful revegetated cut slope along US-95

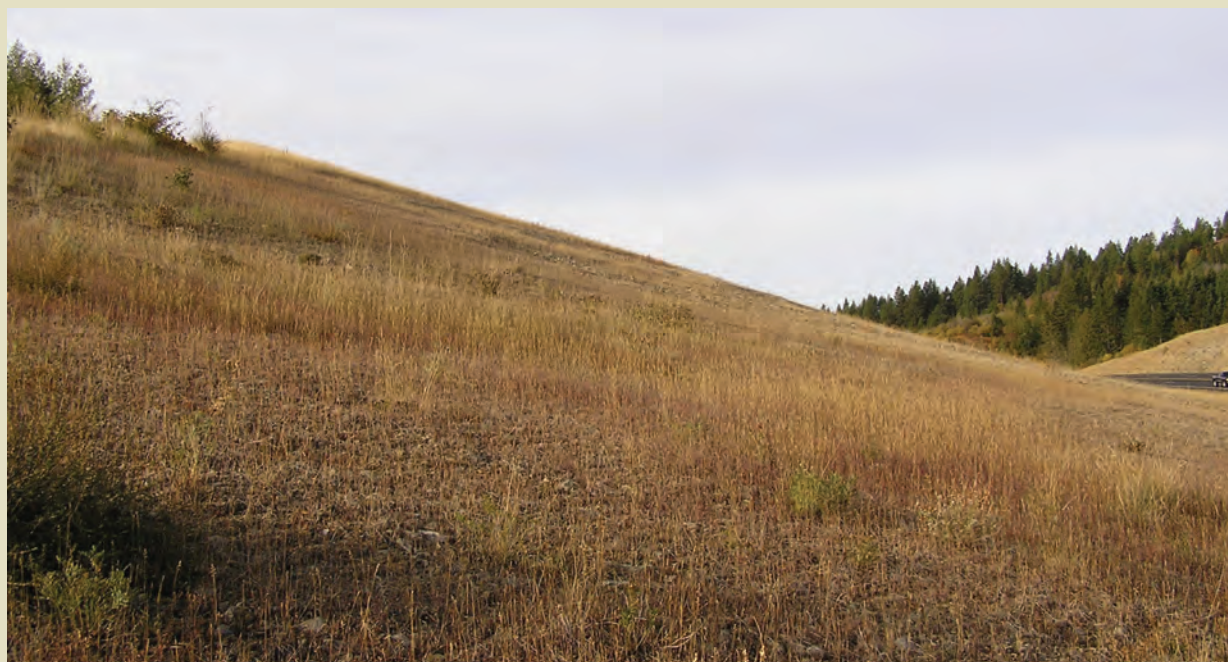
**Figure 29.** Revegetated cut slope on US-95

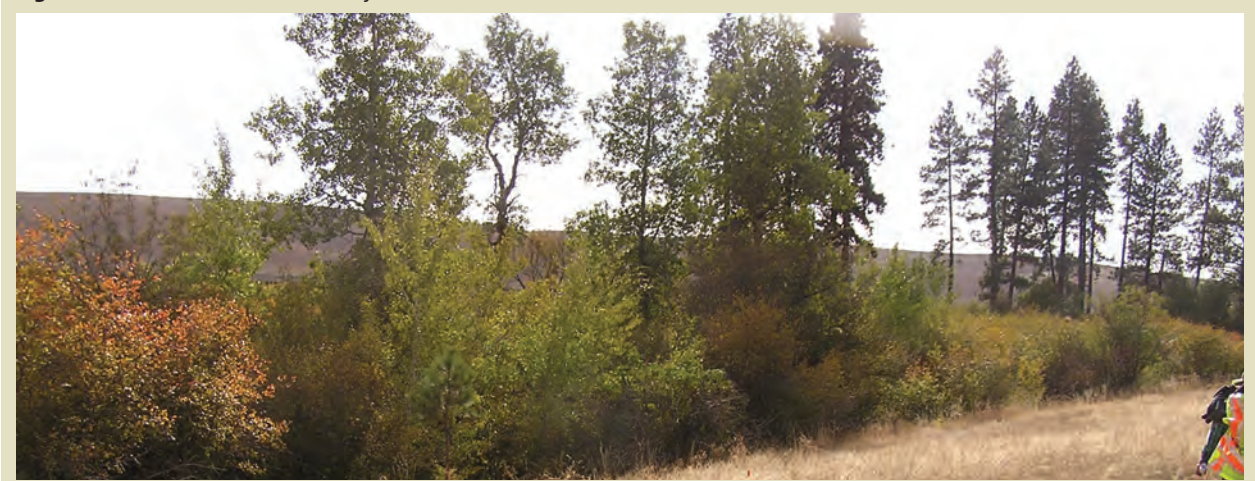
**Figure 31.** Native Plant Research Project transects
