# Current and Innovative Solutions to Roadside Revegetation Using Native Plants

## A DOMESTIC SCAN REPORT

1. Report No. FHWA-WFL/TD-11-001	2. Government Accession No.	3. Recipient's Catalog No.	
4. Title and Subtitle  <b>Current and Innovative Solutions to Roadside Revegetation Using Native Plants A domestic scan report</b>		5. Report Date January 2011

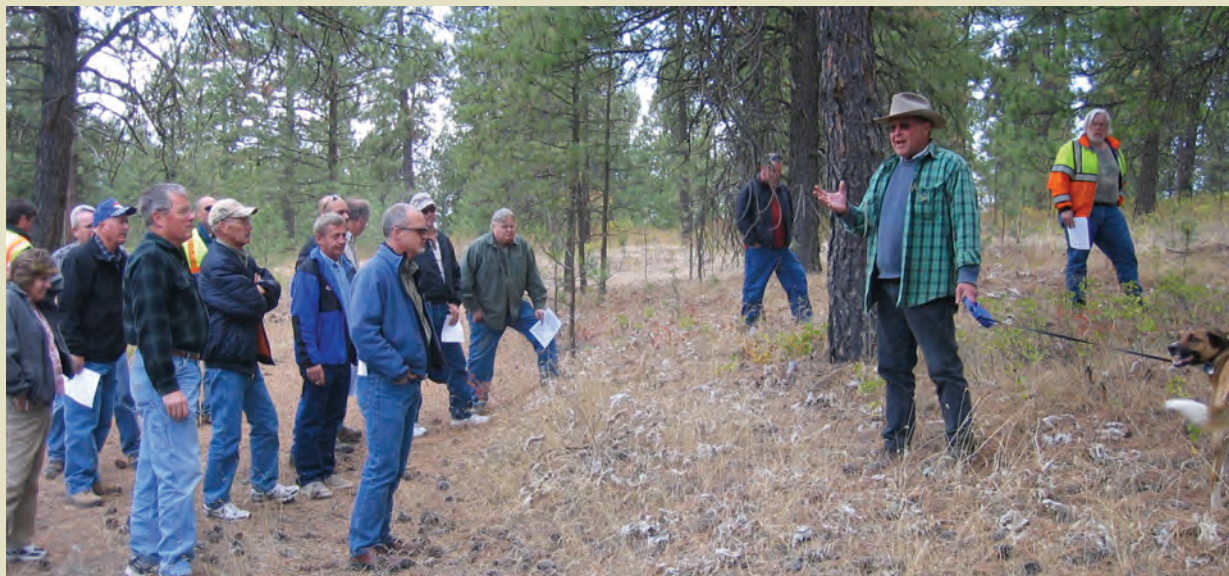
**Figure 32.** Native Plant Research Project reference site

The seeded areas are beginning to establish native grasses, although, these areas are not comparable yet to the reference sites (Figure 32). The current site coverage for native species is approximately 13%. The current site coverage for non-seeded species is approximately 14%. This demonstrates an overall coverage of approximately 27% after one year of monitoring.
